Appendix C
Historical Reports

**ENVIRONMENTAL ASSESSMENT
For
REAL ESTATE TRANSACTION**

1245 Oro Dam Boulevard, Oroville, CA
APN: 035-270-016

**PHASE I ENVIRONMENTAL ASSESSMENT PROCESS
ASTM E 1527-97**

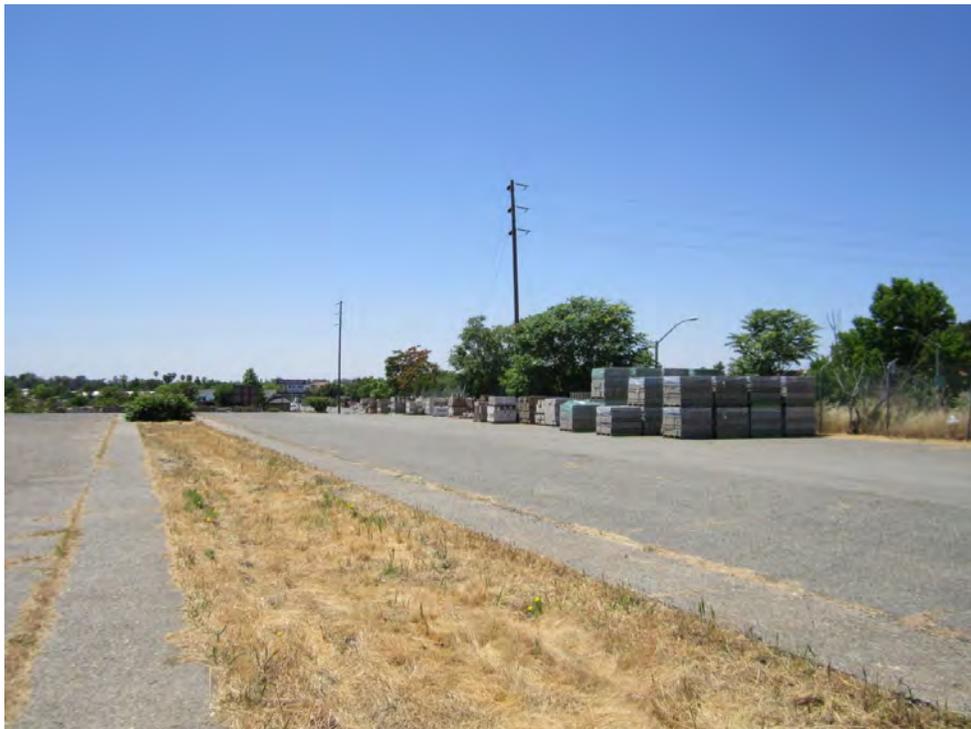
Photo 2. This photo is facing west and depicts the former railroad spur.

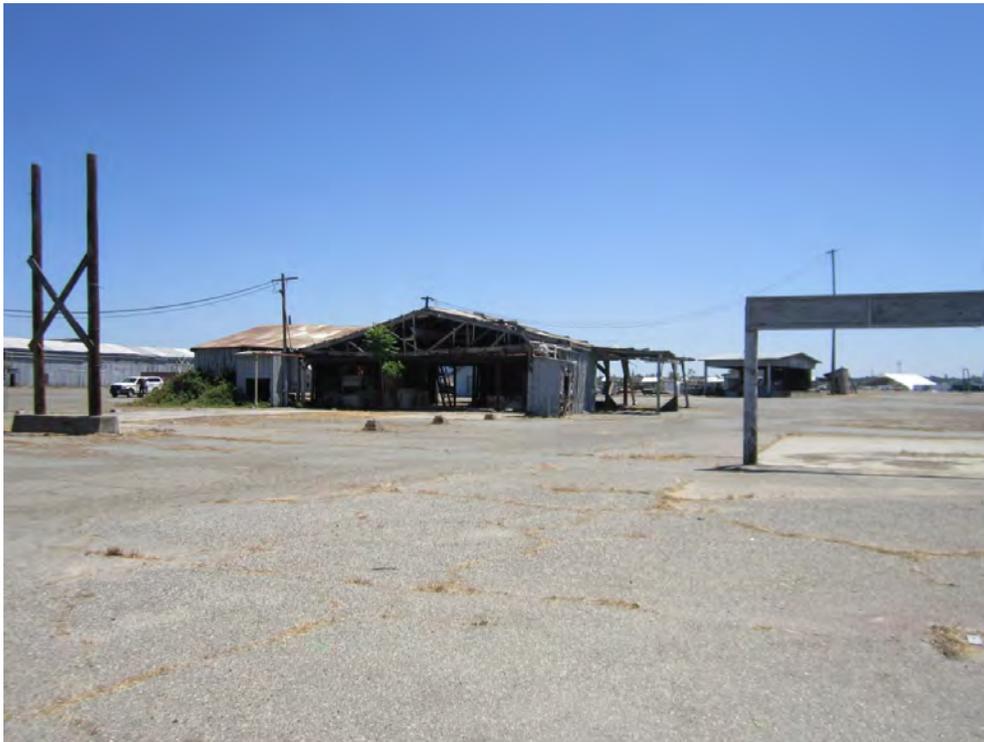
Photo 3. This photo is facing southwest and depicts the former green chain/planing mill. The area of the former electrical shop can be seen to the right.

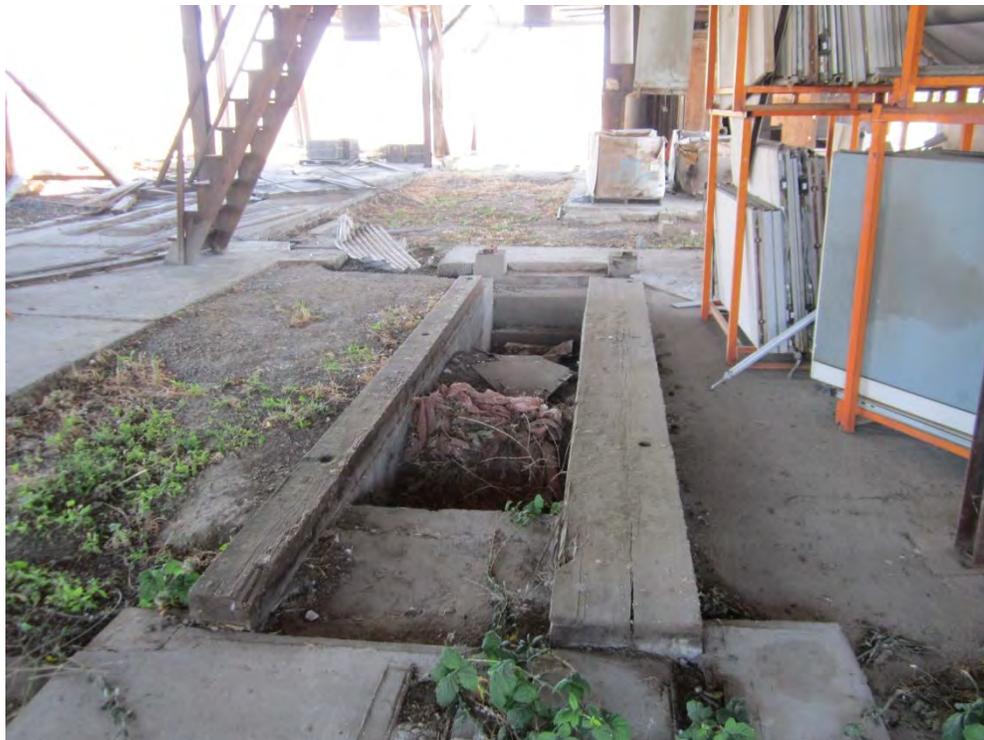
Photo 4. This photo is facing west and depicts the sump in the former green chain/planing mill.

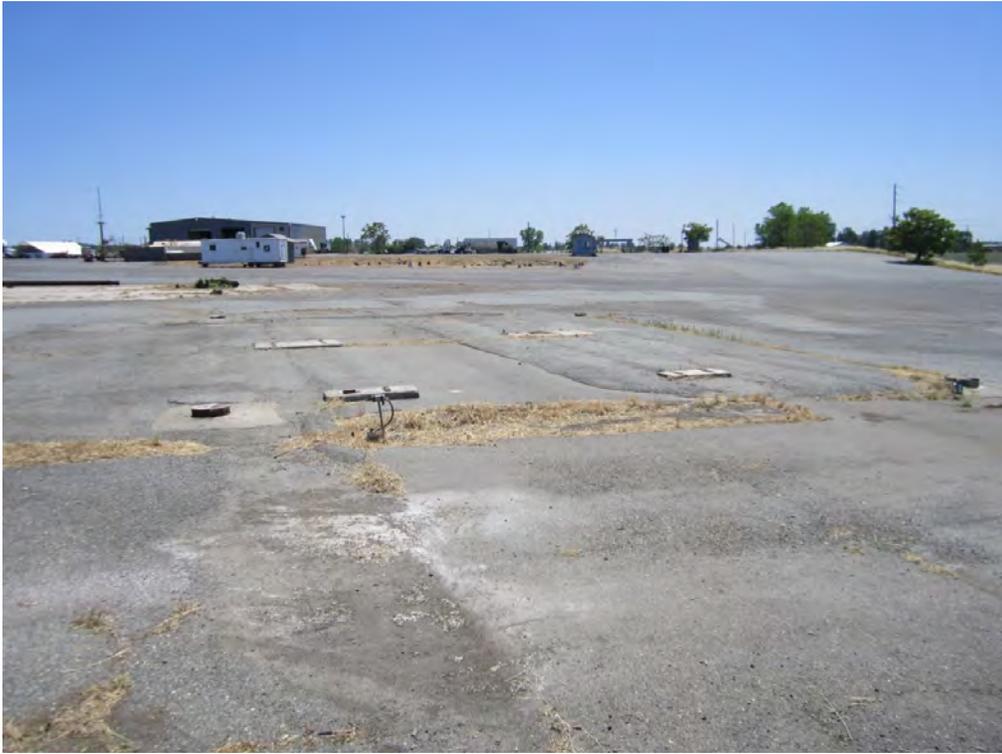
Photo 5. This photo is facing south and aligned with the Veatch Street Extension Easement. The leased mechanic's shop can be seen in the background.

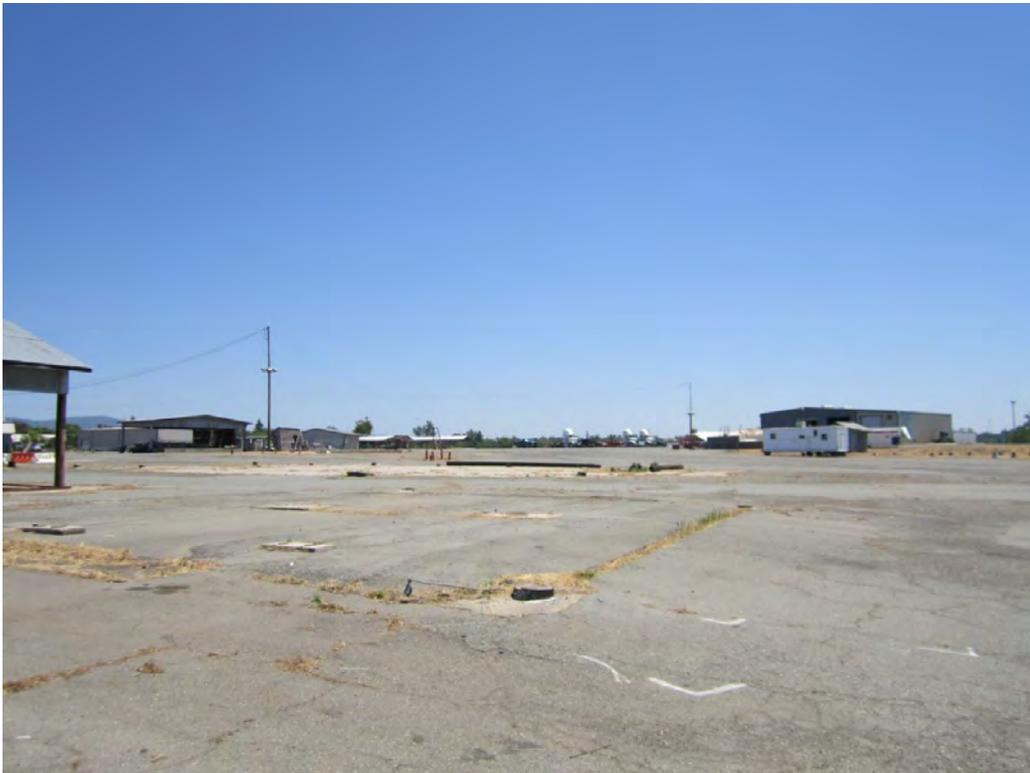
Photo 6. This photo is facing southwest and depicts former lumber mill building foundations, including areas of the former electrical shop, oil house, and machine shop.

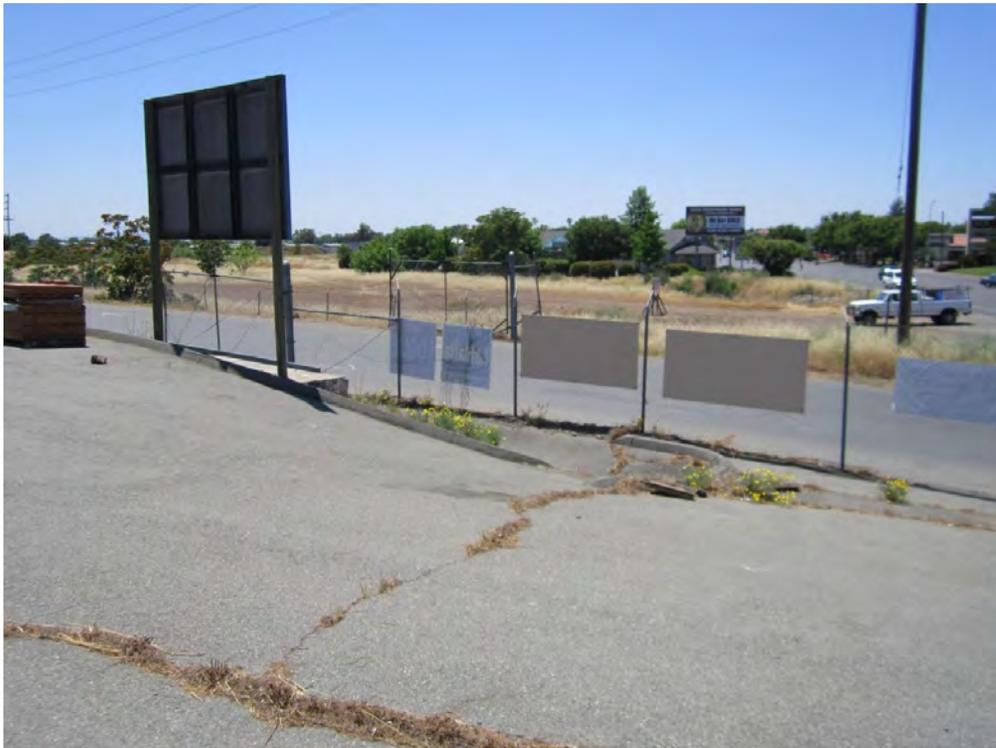
Photo 7. This photo is facing west along the northwest border of the parcel. The curbed stormwater collection drain inlet can be seen in the center of the photo.

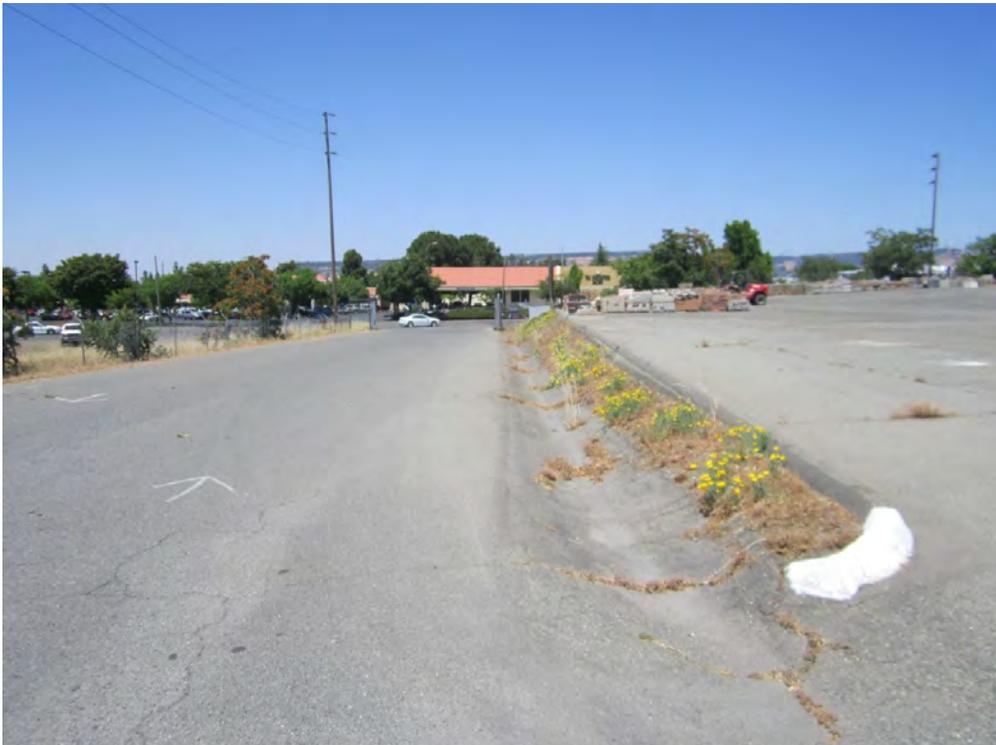
Photo 8. This photo is facing north along the northwest border of the parcel. The stormwater collection swale can be seen in the center of the photo; undeveloped land, located adjacent to the parcel, can be seen to the left of the photo. The northwest facility entrance can be seen in the background.

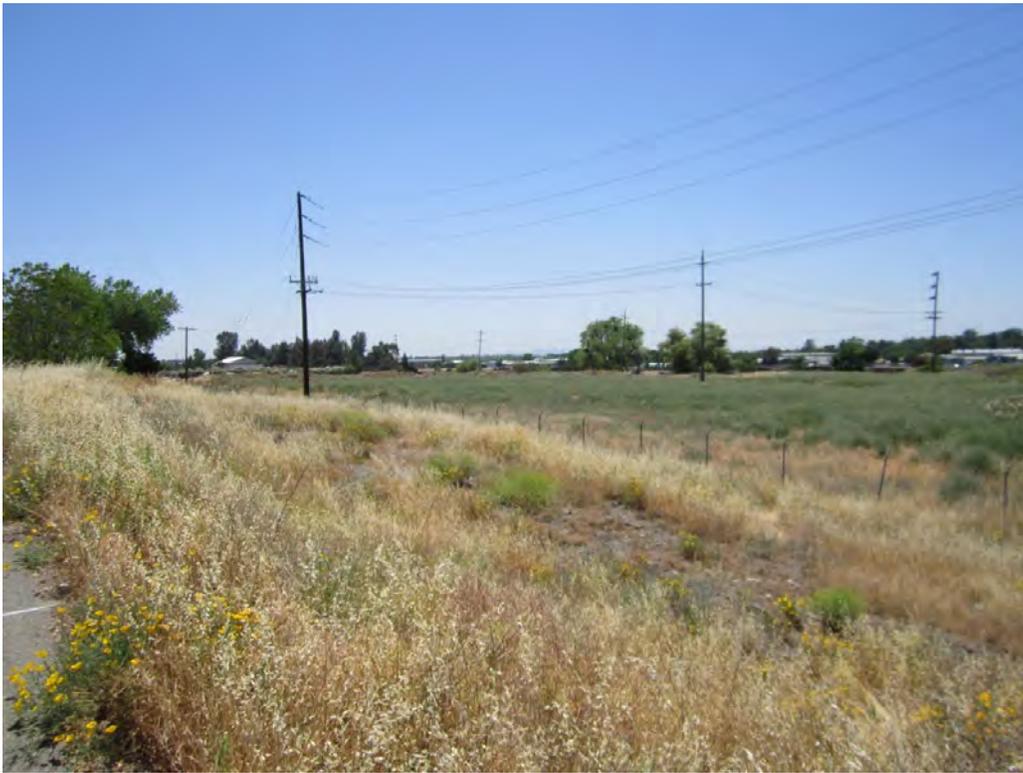
Photo 9. This photo is facing south along the western border of the parcel. Adjacent undeveloped land can be seen to the left of the photo.

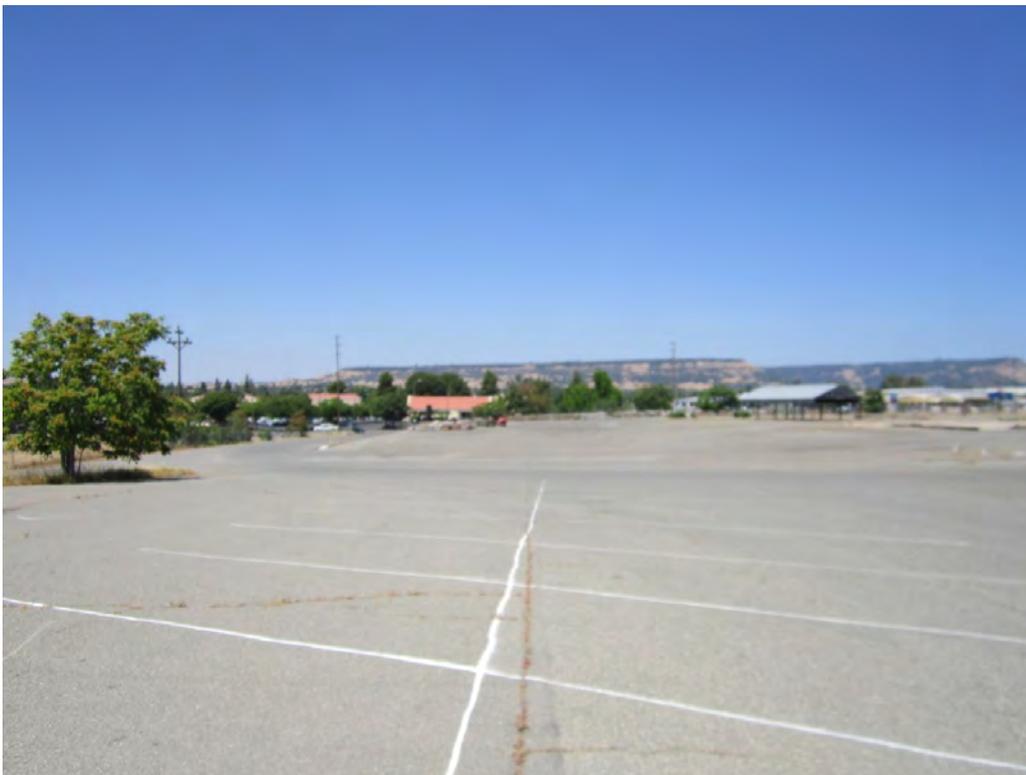
Photo 10. This photo is facing north. The Veatch Street Extension Easement area can be seen on the right side of the photo.

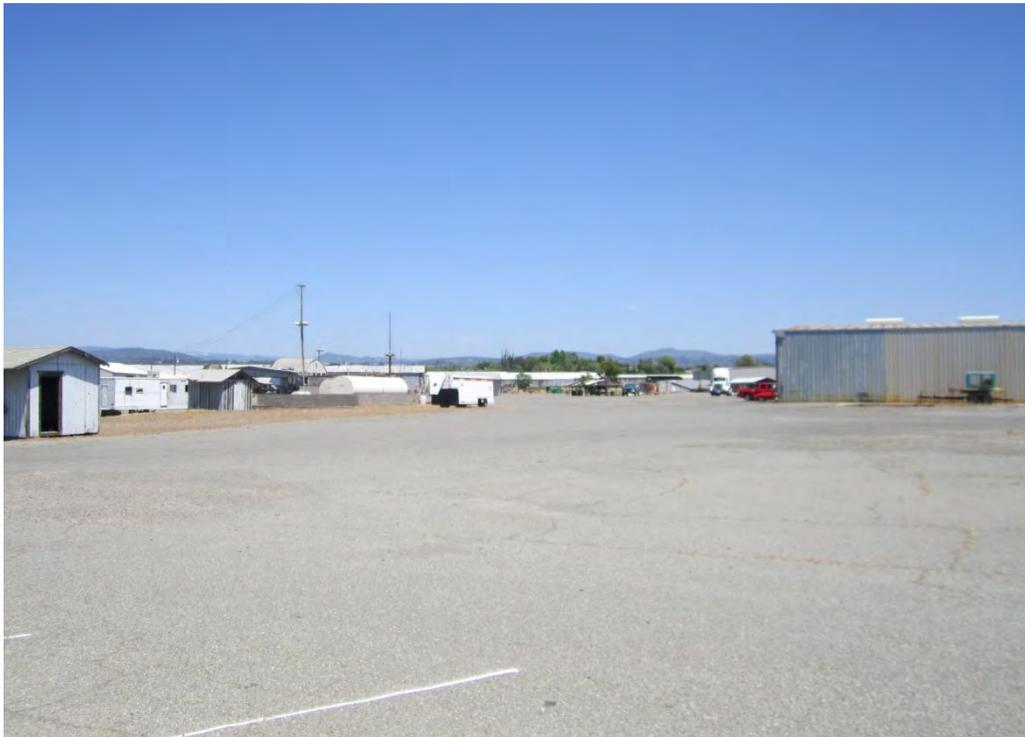
Photo 11. This photo is facing northeast and depicts the AST fueling compound (background, left) and the leased mechanic's shop (background, right).

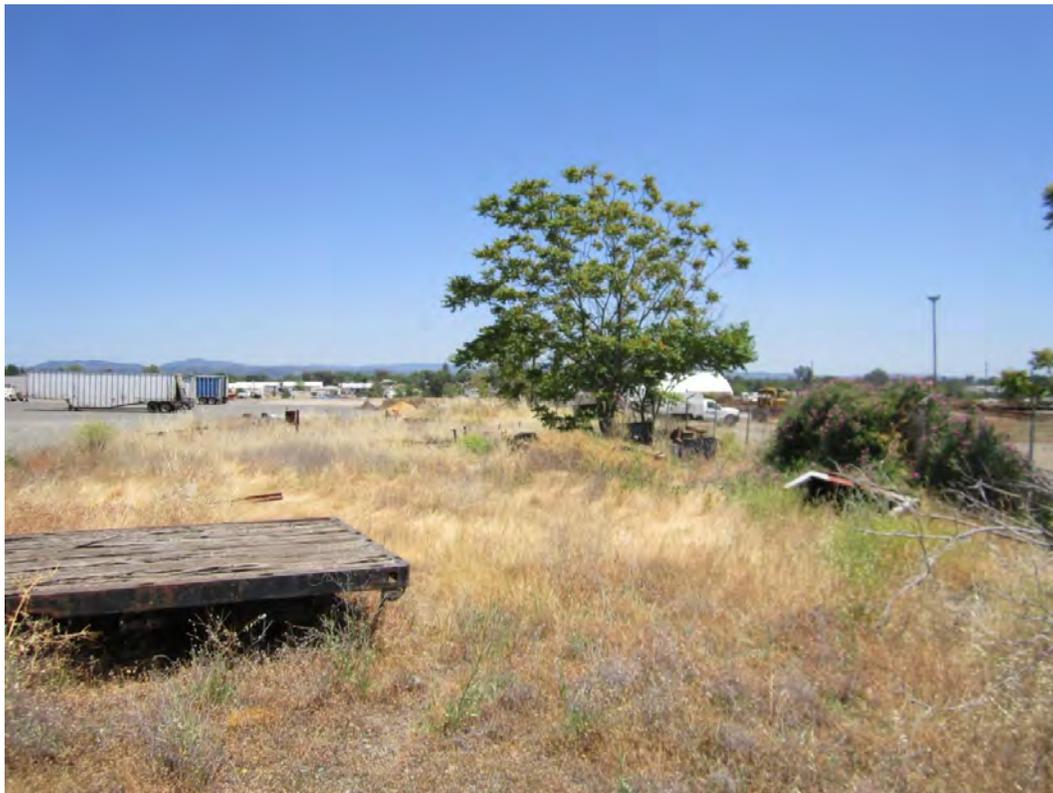
Photo 12. This photo is facing east and depicts an unpaved storage area along the southern parcel fenceline.

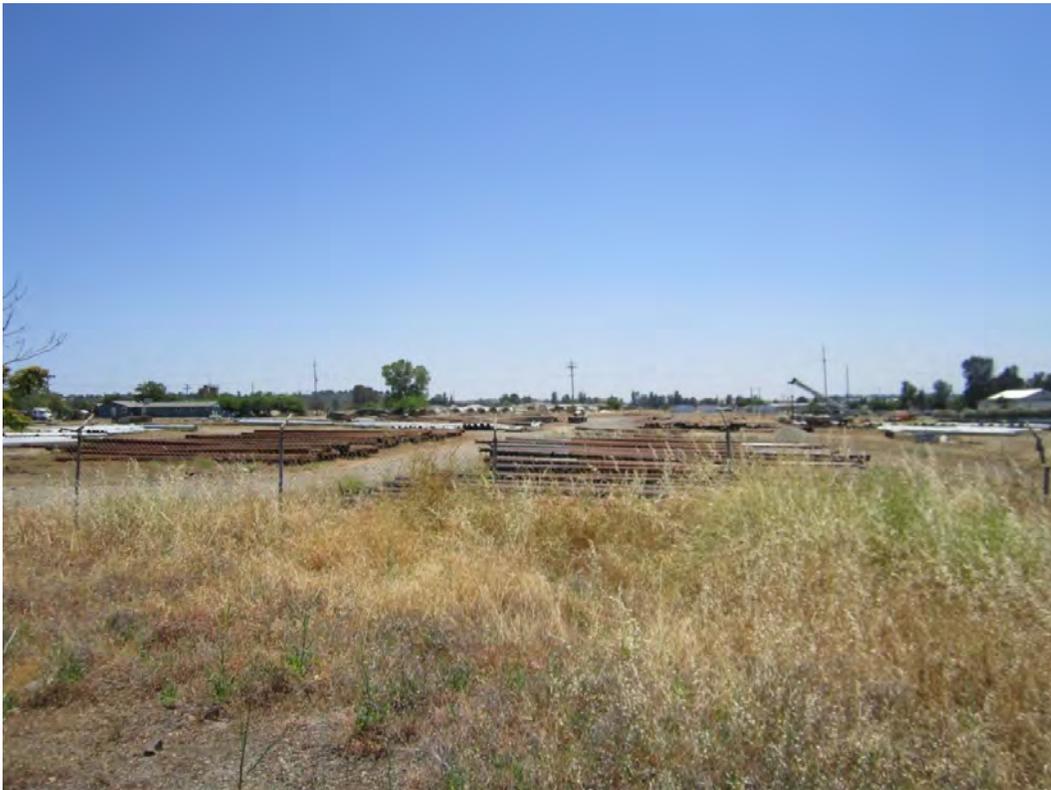
Photo 13. This photo is facing south and depicts a utility storage yard located south of the parcel.

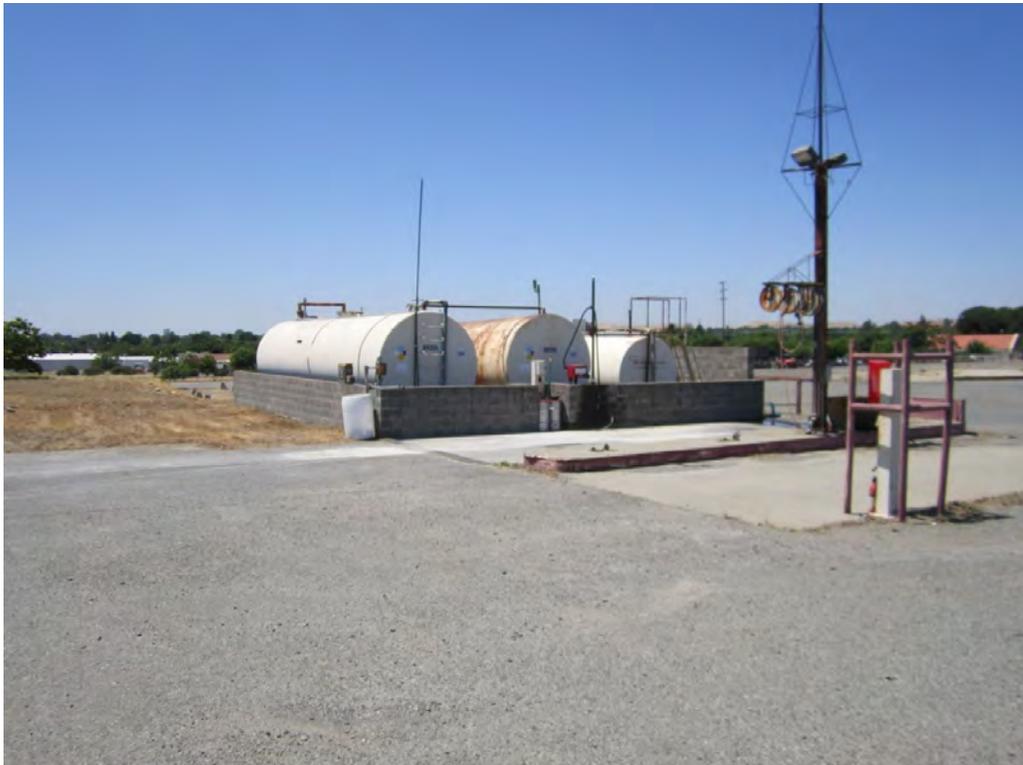
Photo 14. This photo is facing northwest and depicts the AST fueling compound and area of reported former USTs.

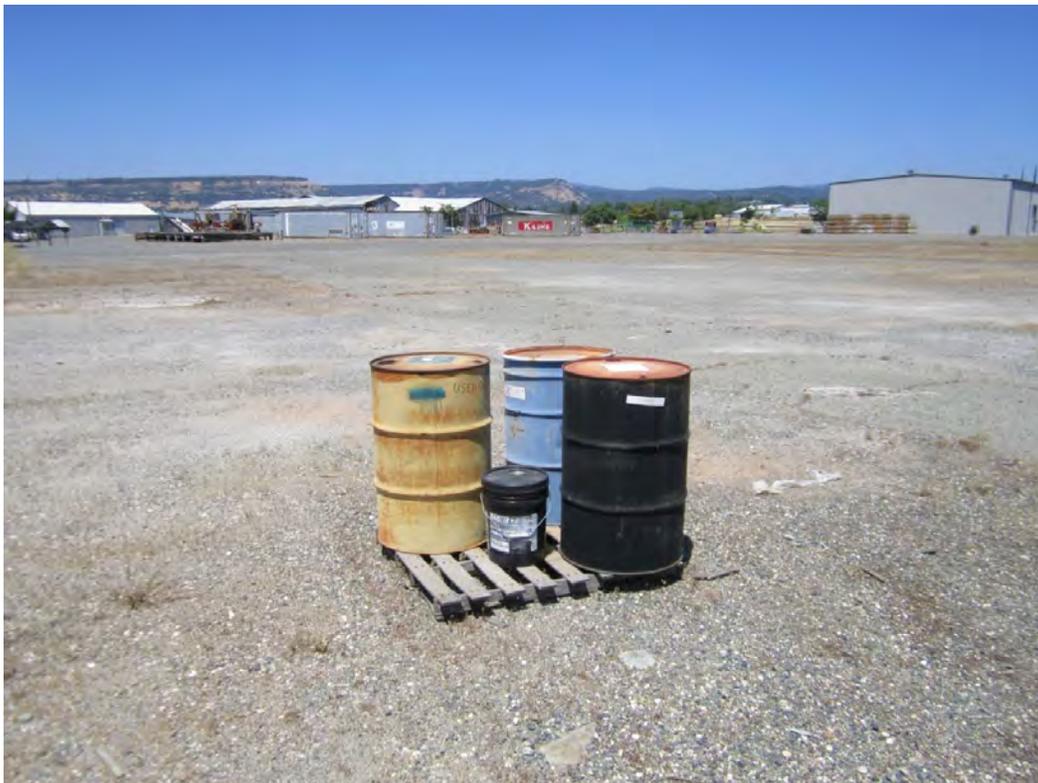
Photo 16. This photo is facing northeast and depicts full drums with unknown contents.

5. There are approximately (20) 55 gallon drums scattered around the property which are believed to contain hazardous wastes. These drums should be properly disposed of. There are also approximately (22) 5 gallon pails scattered around the property which are believed to contain hazardous wastes. These drums should be properly disposed of.

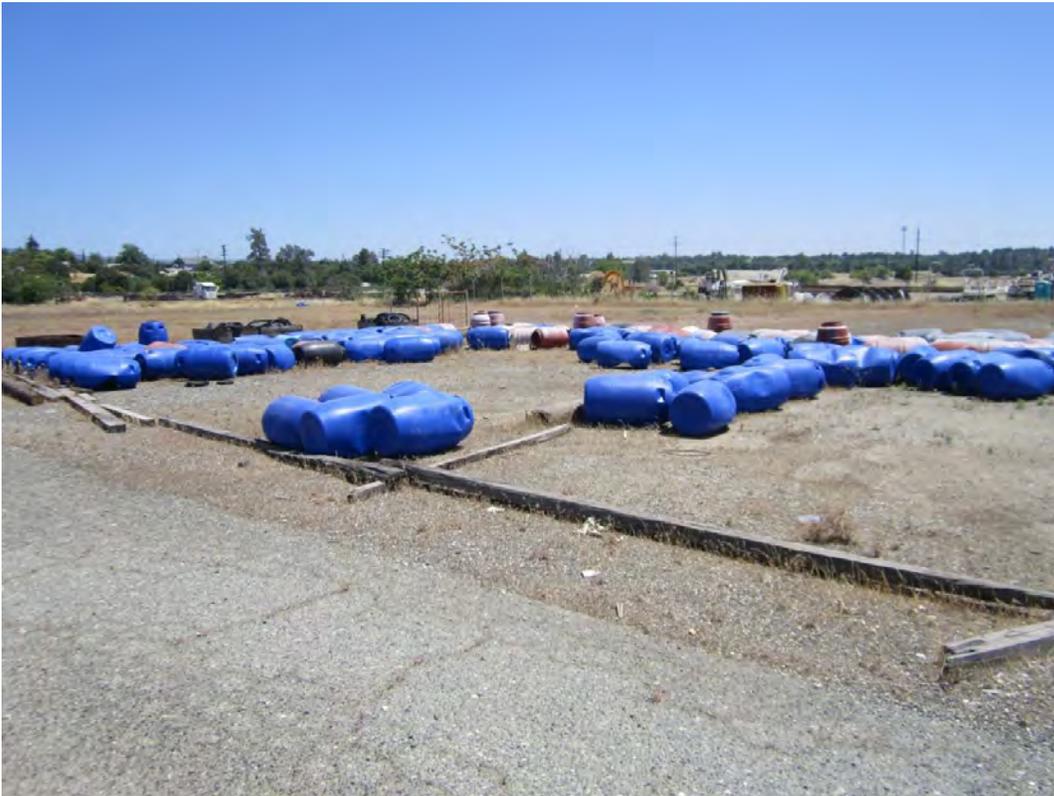
Photo 17. This photo is facing southeast and depicts an empty drum storage area.

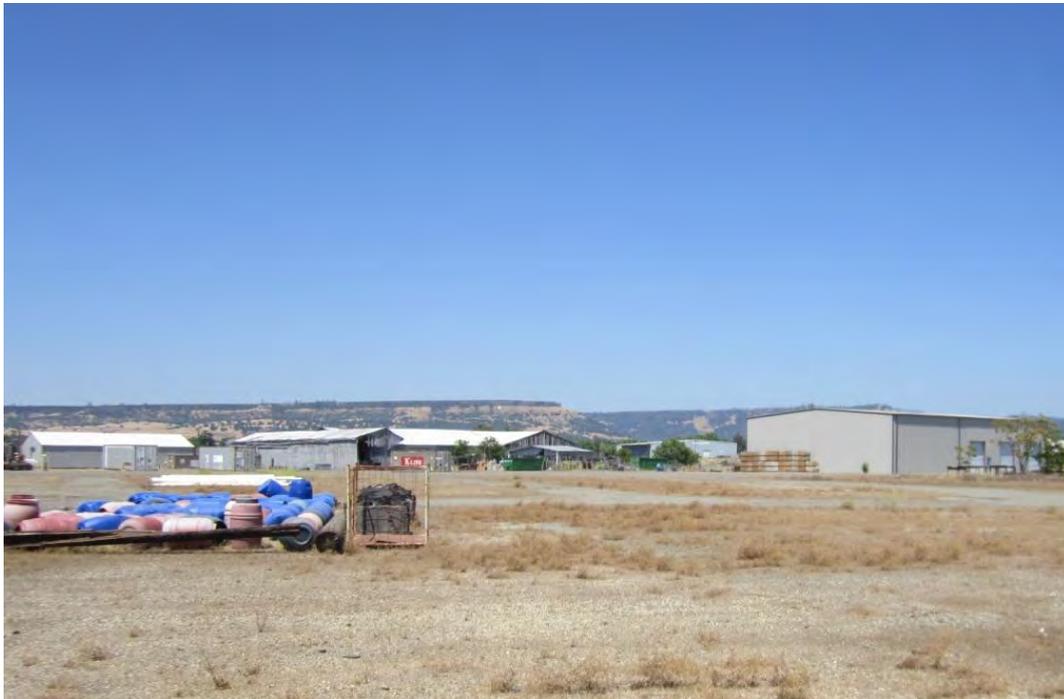
Photo 18. This photo is facing north and depicts various former lumber mill buildings leased by commercial and industrial businesses.

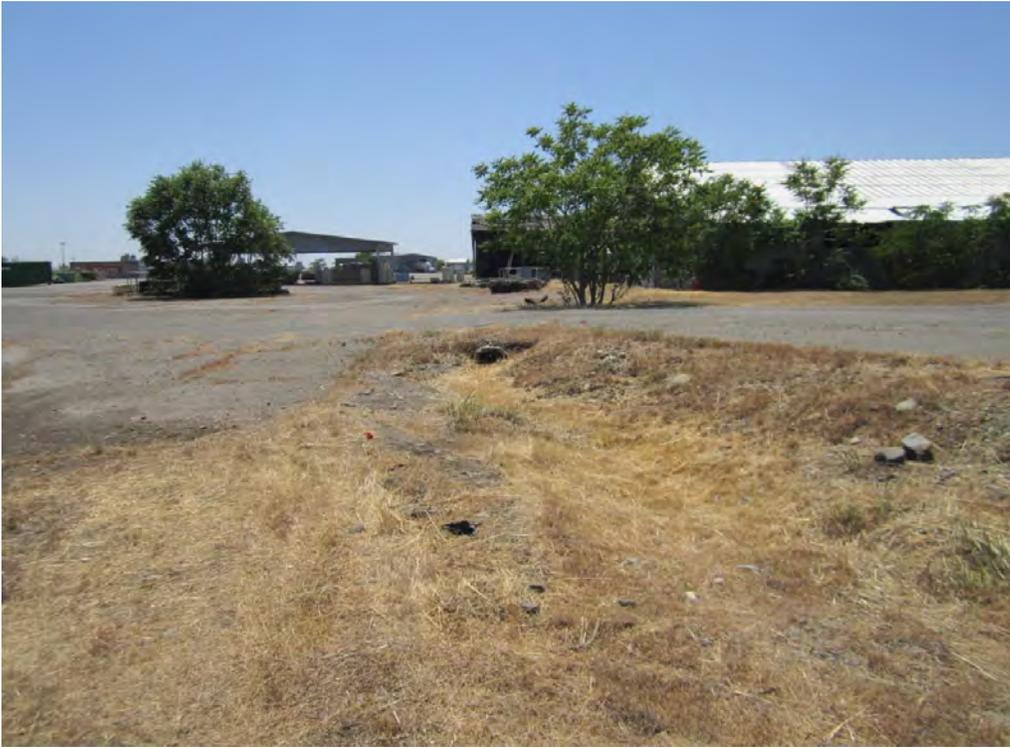
Photo 19. This photo is facing west and depicts an unpaved stormwater drainage swale. Former lumber mill buildings can be seen in the background. The buildings are leased by commercial and industrial businesses.

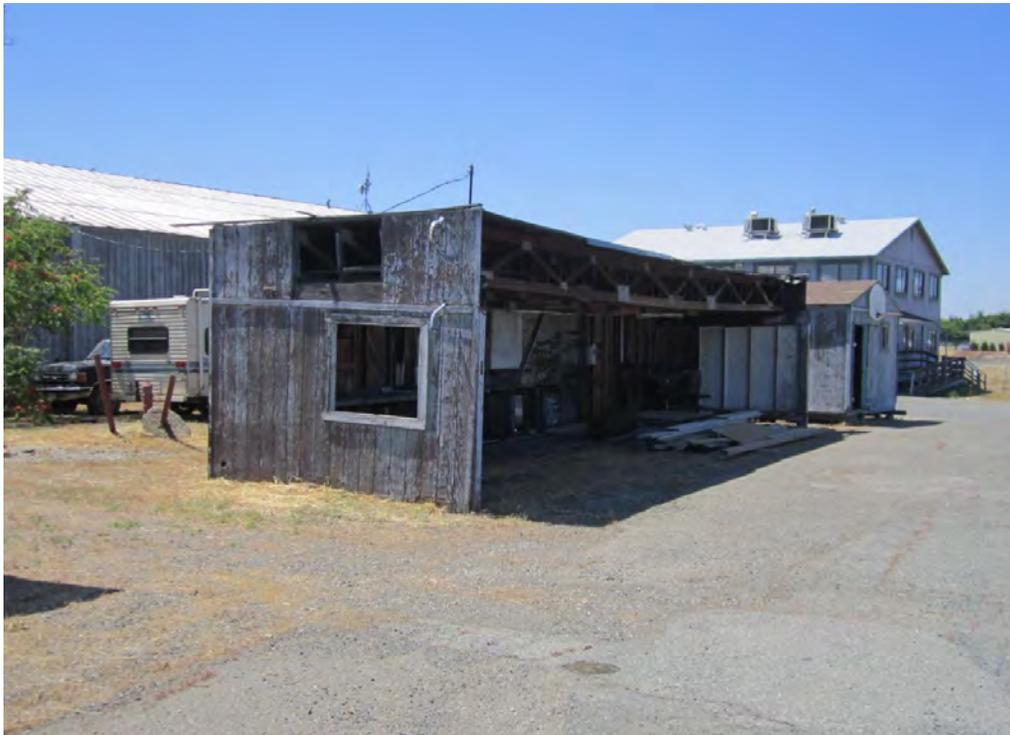
Photo 20. This photo is facing north and depicts a dilapidated former lumber mill building. The former lumber mill complex can be seen in the background, (also known as the former box factory). The buildings are leased by commercial and industrial businesses.

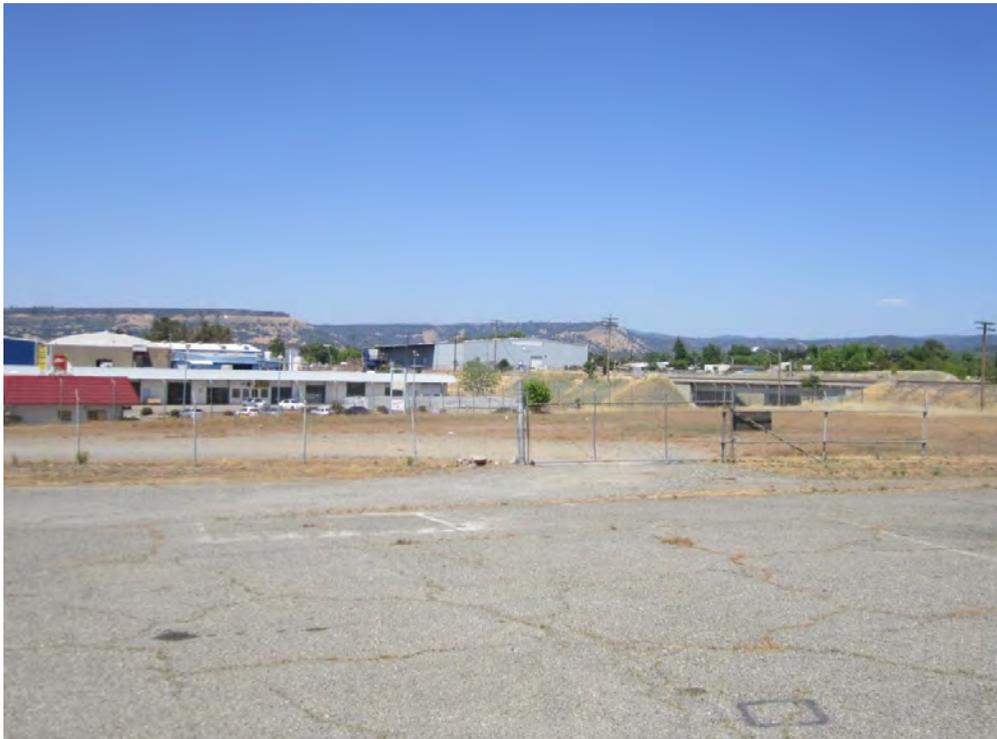
Photo 21. This photo is facing northeast and depicts the adjacent railroad easement (at right) along with neighboring businesses located across Oroville Dam Boulevard (background).

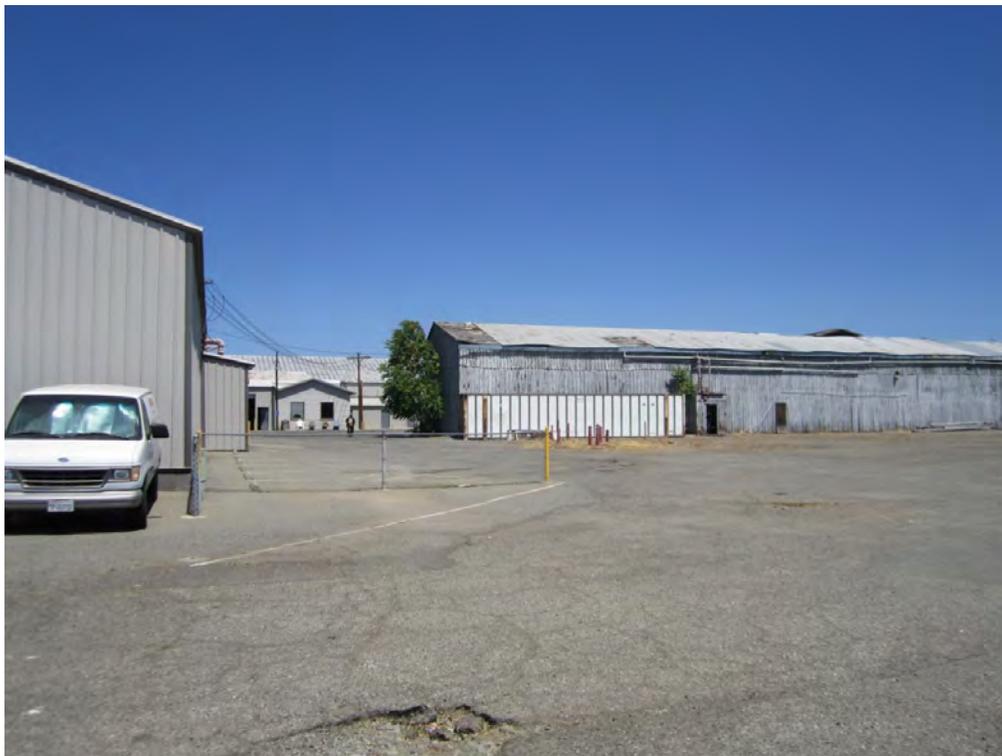
Photo 22. This photo is facing east and depicts the former lumber mill complex (also known as the former box factory). The complex is leased by commercial and industrial businesses.

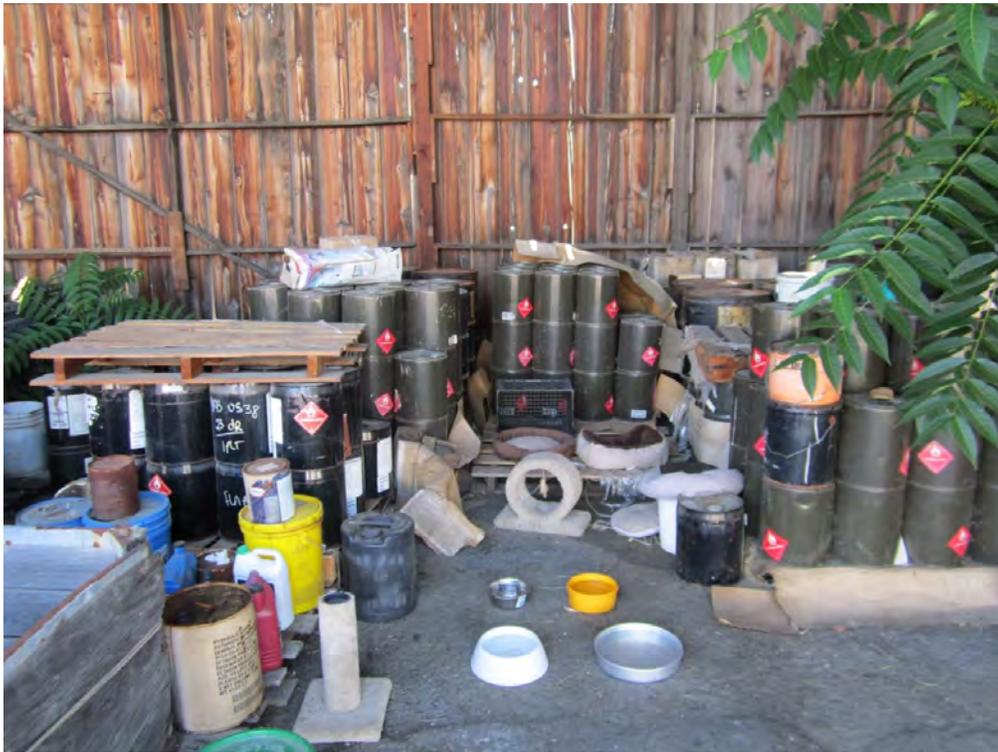
Photo 23. This photo depicts various quantities of solvent and other unknown chemicals observed in a former lumber mill leased space.

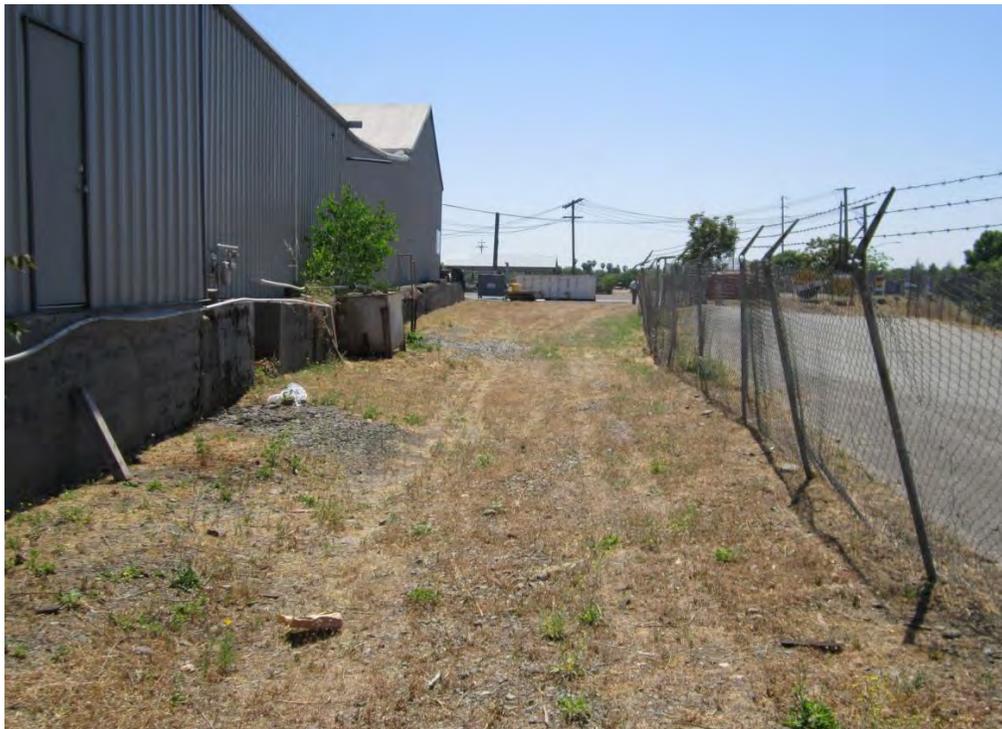
Photo 24. This photo is facing west and taken along the northern wall of the former lumber mill complex (also known as the box factory), along the alignment of the former railroad spur. A leased space used as a work training center and small container recycling facility is located in the center/background.

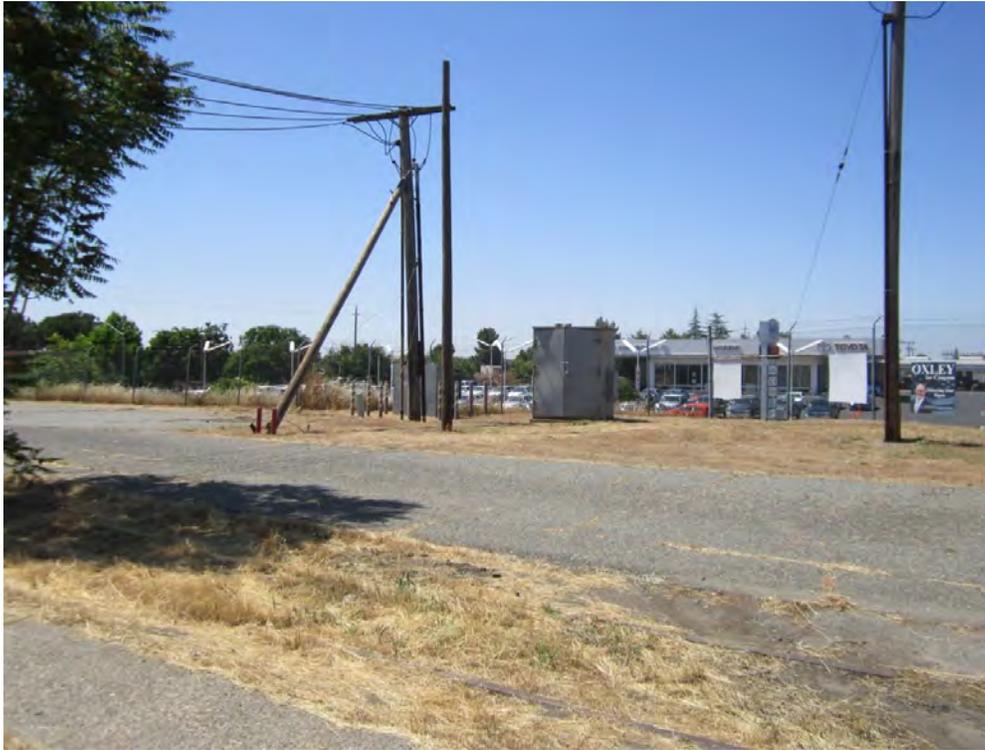
Photo 25. This photo is facing north and depicts a site transformer, former location of the teepee burner, and remnants of the railroad spur (foreground). The auto sales facility located across Oroville Dam Boulevard can be seen in the background.
