Appendix D
Agency Records

POTENTIALLY RESPONSIBLE PARTY SEARCH REPORT

CALIFORNIA WATER SERVICE COMPANY
WELL NO. 05-01
1752 Fort Wayne Street
Oroville, California 95966

March 3, 2014
Project Number 13-100333.1A

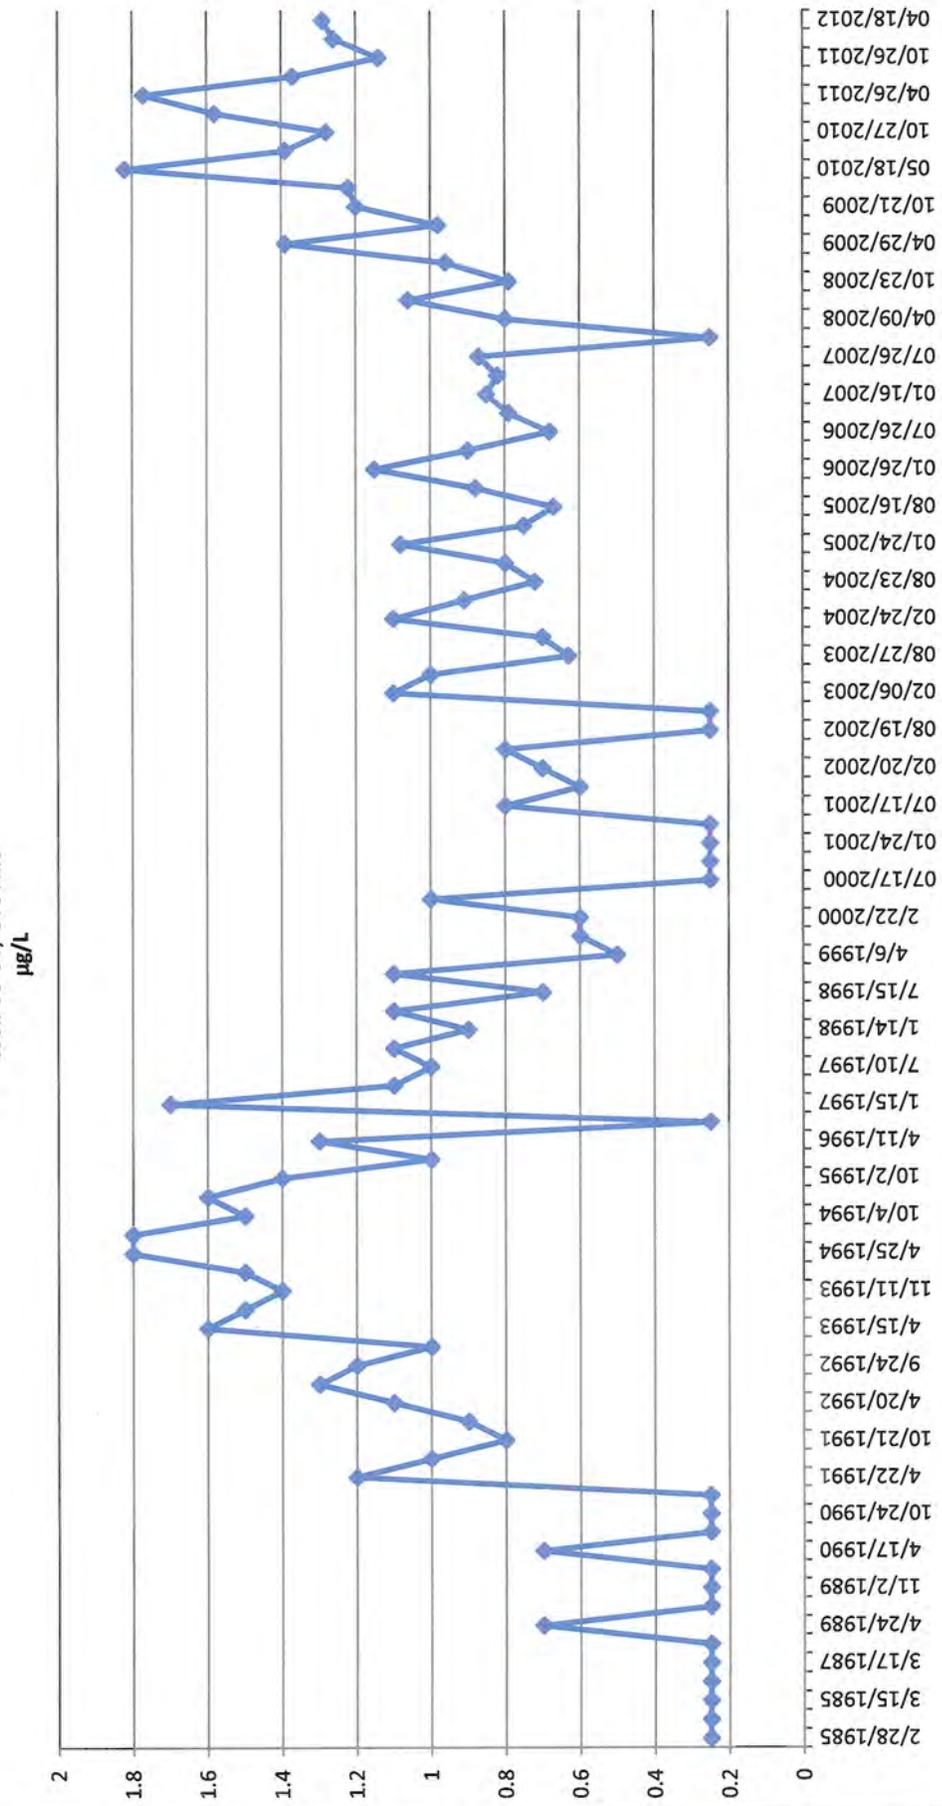
PCE, Cal Water Service Co.
Well 05-01, Oroville
µg/L

Date	PCE (µg/L)
2/28/1985	0.25
2/28/1985	0.25
3/15/1985	0.25
9/3/1986	0.25
3/17/1987	0.25
8/18/1988	0.25
4/24/1989	0.7
7/12/1989	0.25
11/2/1989	0.25
1/18/1990	0.25
4/17/1990	0.7
7/23/1990	0.25
10/24/1990	0.25
1/23/1991	0.25
4/22/1991	1.2
7/25/1991	1
10/21/1991	0.8
1/23/1992	0.9
4/20/1992	1.1
7/13/1992	1.3
9/24/1992	1.2
1/20/1993	1
4/15/1993	1.6
7/6/1993	1.5
11/11/1993	1.4
1/12/1994	1.5
4/25/1994	1.8
7/28/1994	1.8
10/4/1994	1.5
4/4/1995	1.6
10/2/1995	1.4
1/4/1996	1
4/11/1996	1.3
7/2/1996	0.25
1/15/1997	1.7
4/23/1997	1.1
7/10/1997	1
10/6/1997	1.1
1/14/1998	0.9
4/1/1998	1.1
7/15/1998	0.7
10/1/1998	1.1
4/6/1999	0.5
7/13/1999	0.6
2/22/2000	0.6
4/18/2000	1
7/17/2000	0.25
10/10/2000	0.25
1/24/2001	0.25
7/17/2001	0.25
7/17/2001	0.8
10/17/2001	0.6
2/20/2002	0.7
5/28/2002	0.8
8/19/2002	0.25
10/28/2002	0.25
2/06/2003	1.1
5/20/2003	1
8/27/2003	0.63
11/12/2003	0.7
2/24/2004	1.1
5/24/2004	0.91
8/23/2004	0.72
11/17/2004	0.8
1/24/2005	1.08
4/27/2005	0.75
8/16/2005	0.67
10/18/2005	0.88

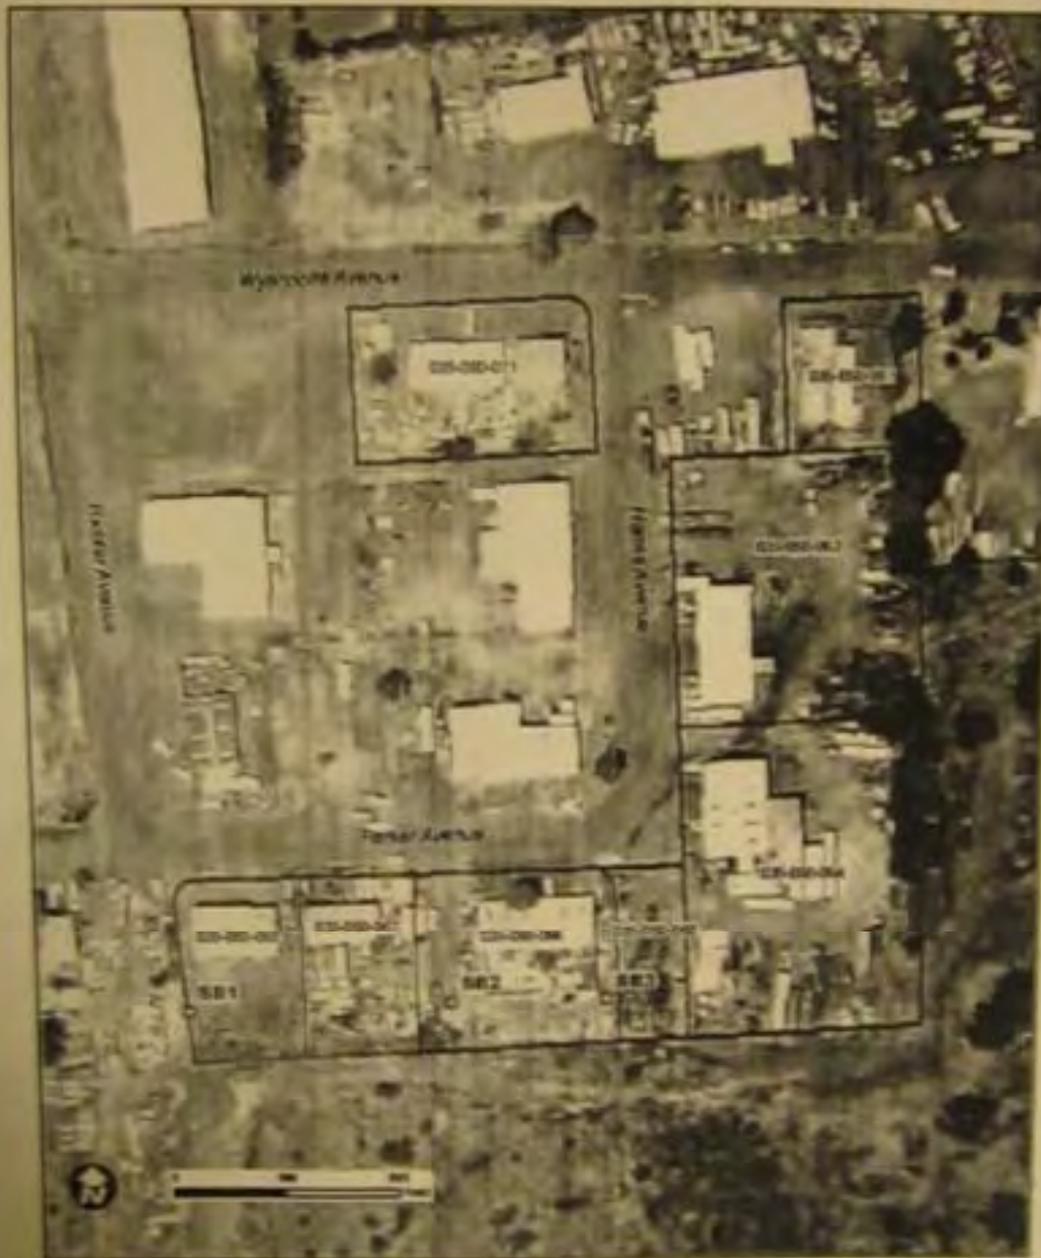
Figure 2: Site Vicinity
Phase II Environmental Site Assessment
Harris and Parker Avenues, Oroville, California

11-11-11 10
SITE VICINITY MAP
BANKS INDUSTRIAL PROPERTIES

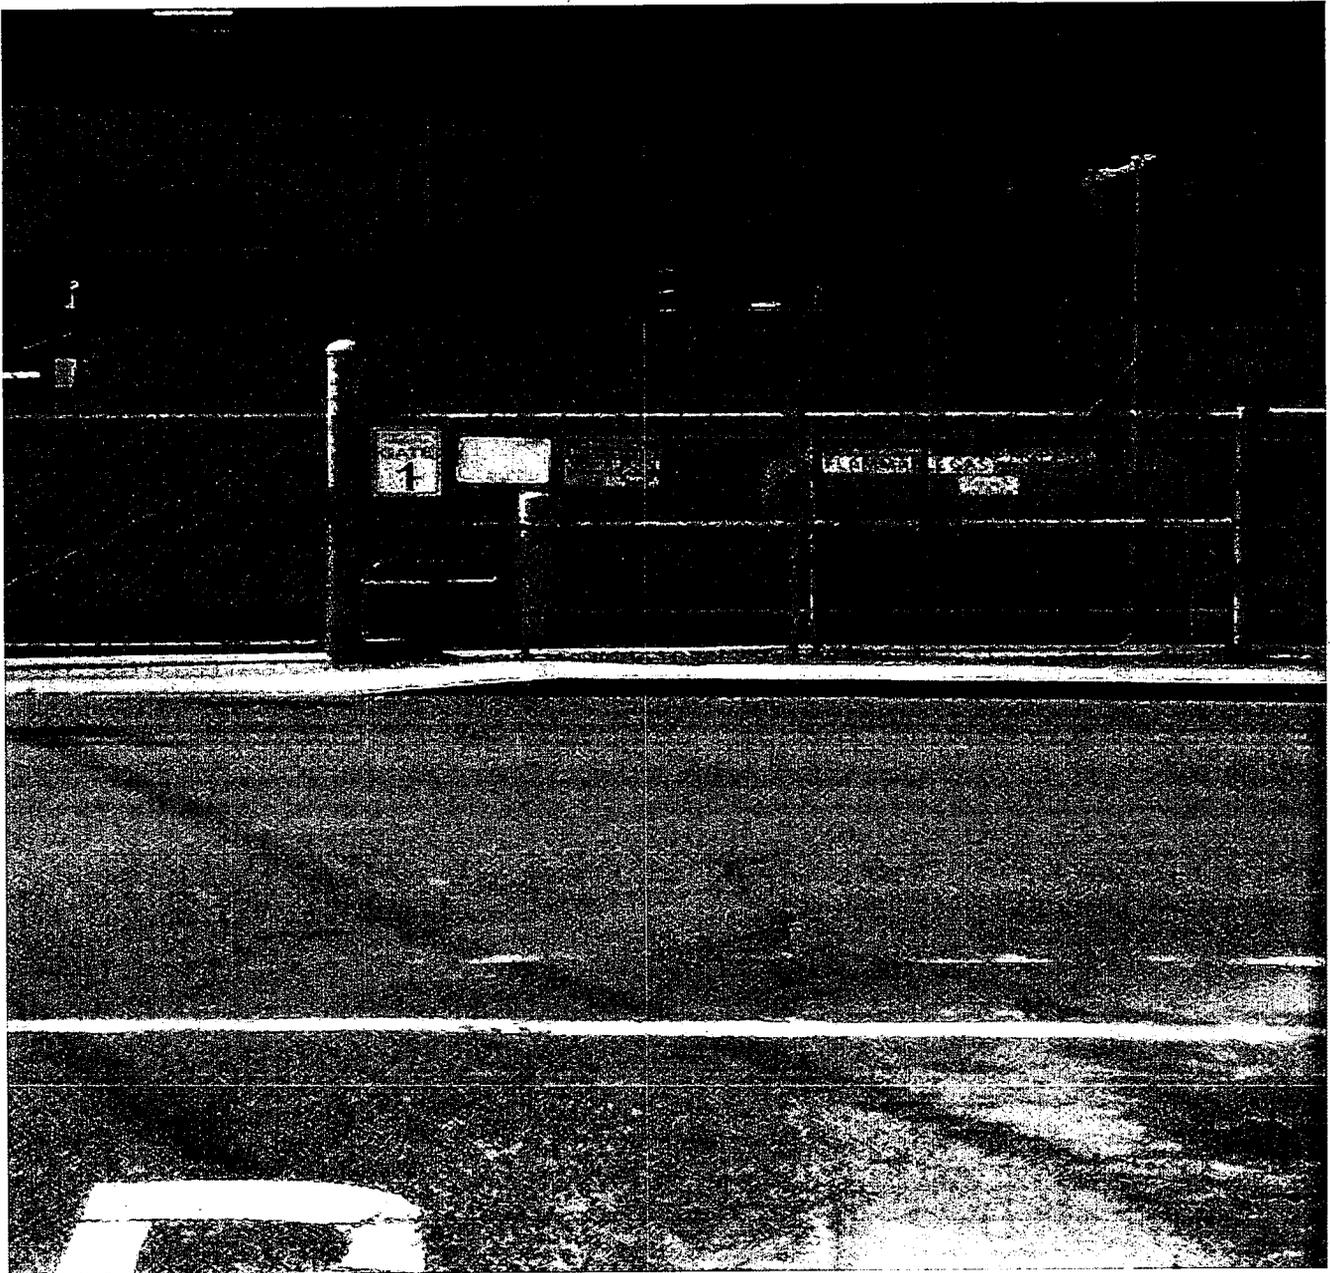
DTSC conducted a site visit on May 3, 2013. The company operates at two locations next to each other. The main processing facility is at 1601 Mitchell Avenue and the warehouse operation is located at 1795 Mitchell Avenue. No evidence of any releases was evident from the visit.

View looking south across Mitchell Avenue at Gate 1 where trucks deliver fruit for processing.

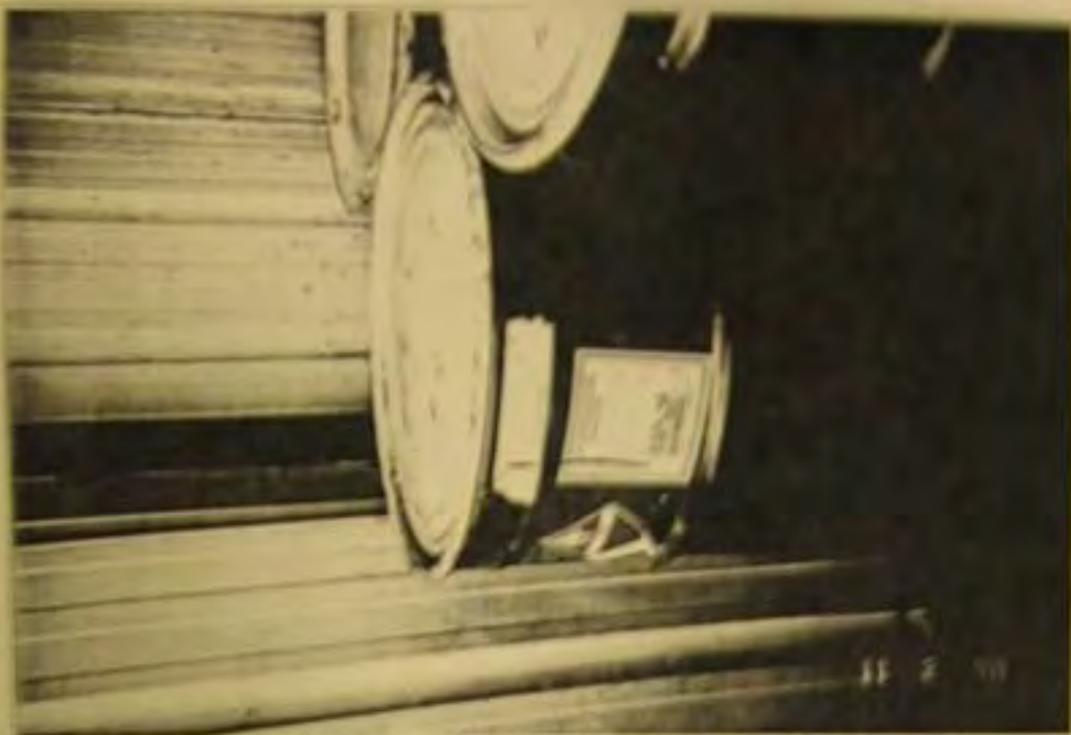
3 Photograph of "waste in" accumulation drum. Note the lack of safety tag to secure lid.
 Location: Hazardous Waste Storage Photographer's direction: Southwest Photographer: Kline

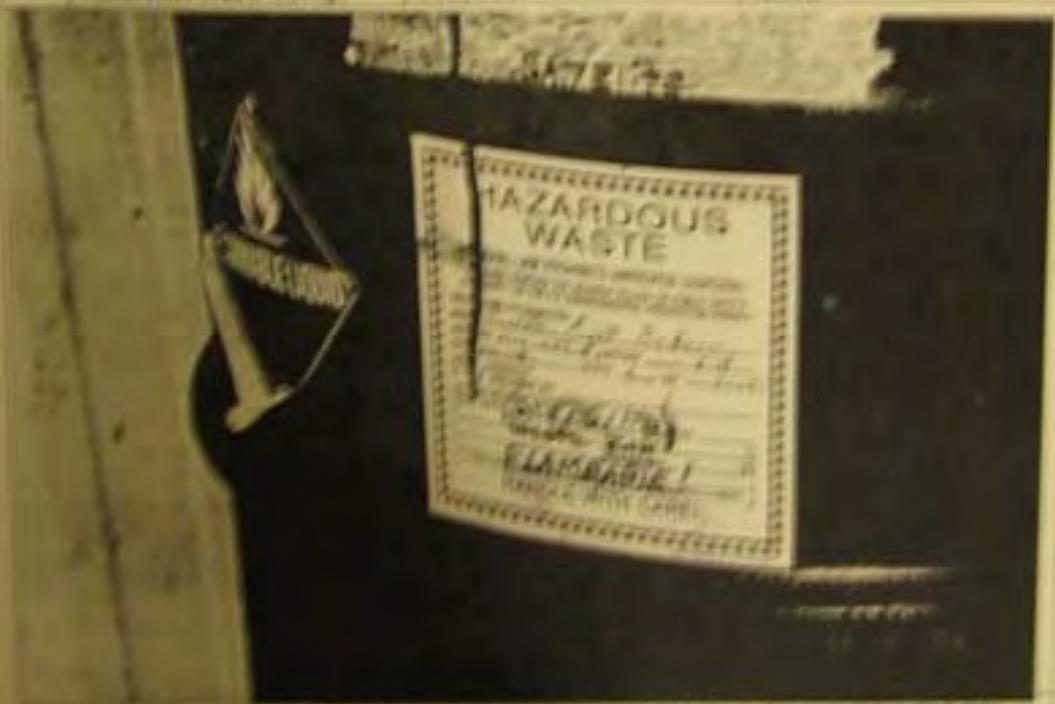
4 Close up photograph of label on drum. Photograph #3. Note lack of governmental seal over label.
 Location: Hazardous Waste Storage Photographer's direction: Southwest Photographer: Kline

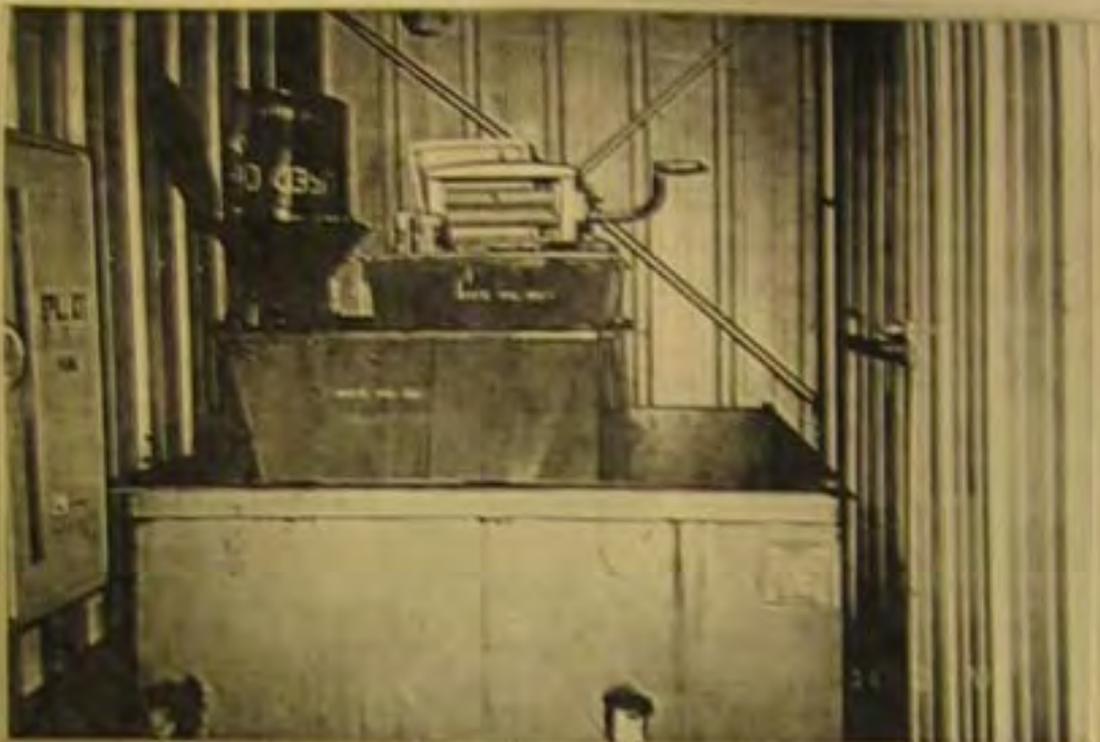
Used Oil storage tank and secondary containment. Note five gallon bucket being emptied into tank. Note label on secondary containment.

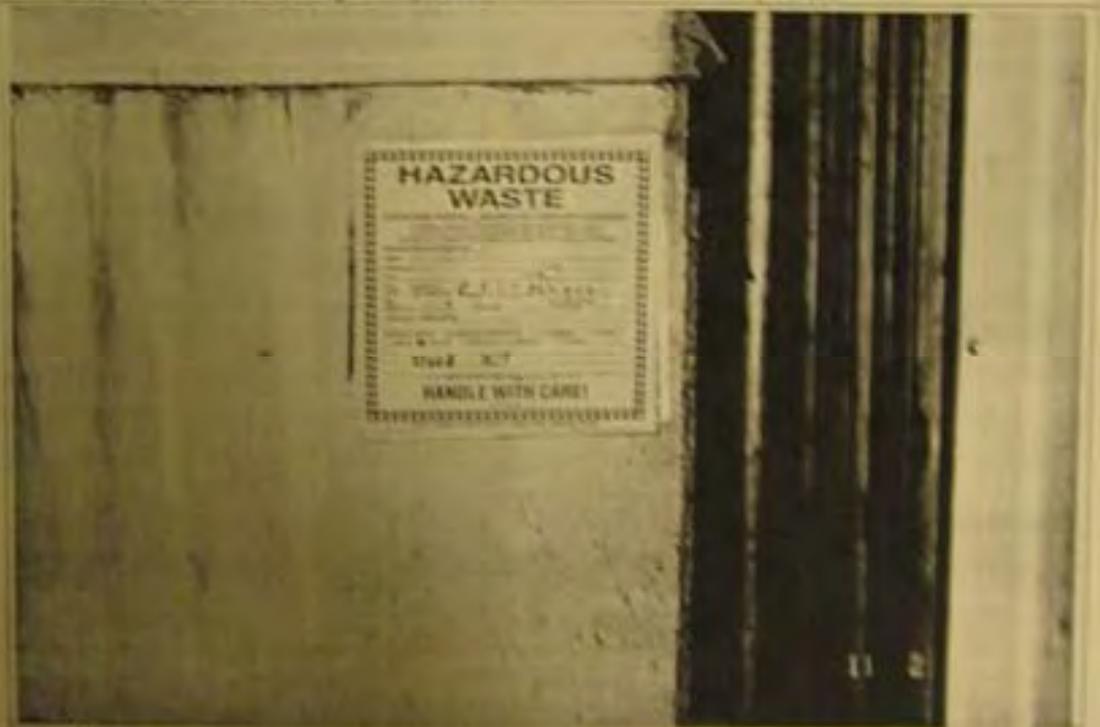
Close up of label on secondary containment.

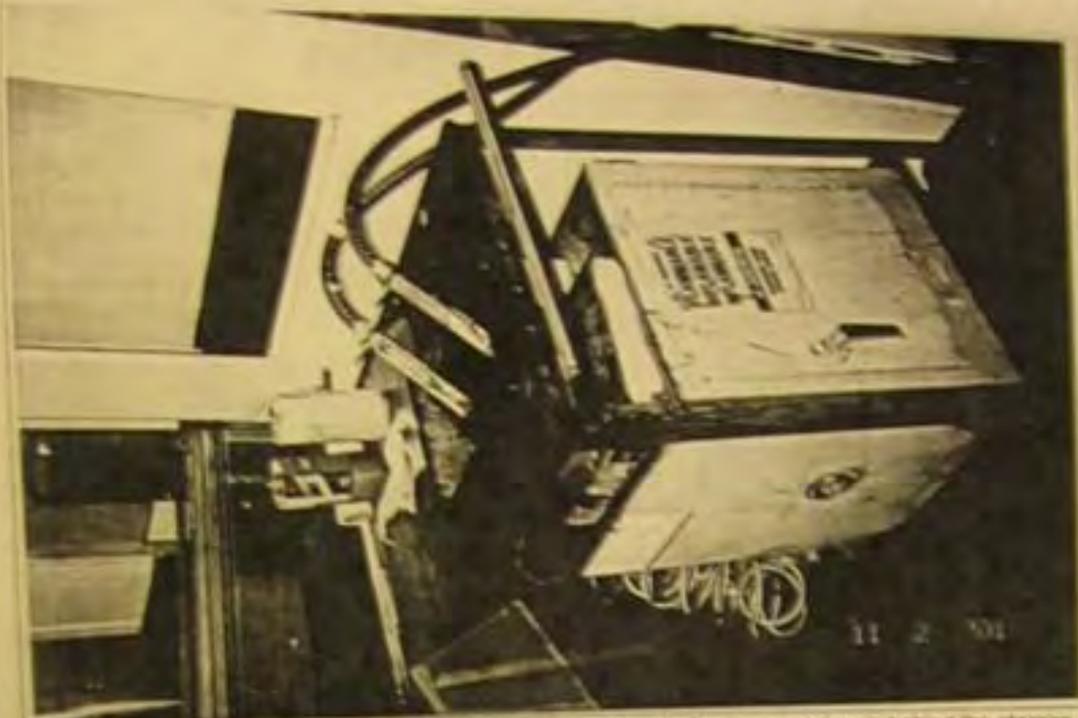
7 Ink-jet nozzles on cleaning cart. Note the waste solvent collection container is behind the storage box with the word "flammable" printed on it.

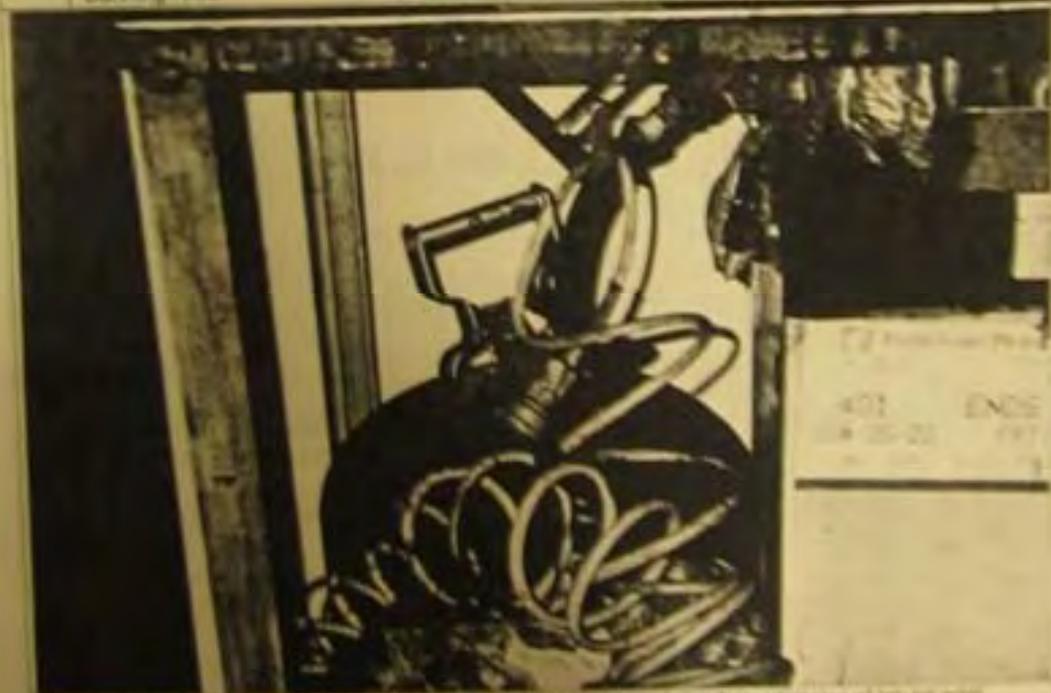
8 Close up photograph of container used to collect waste solvent from cleaning of ink-jet print heads. Note hose leading from top center of photograph into opened safety can.

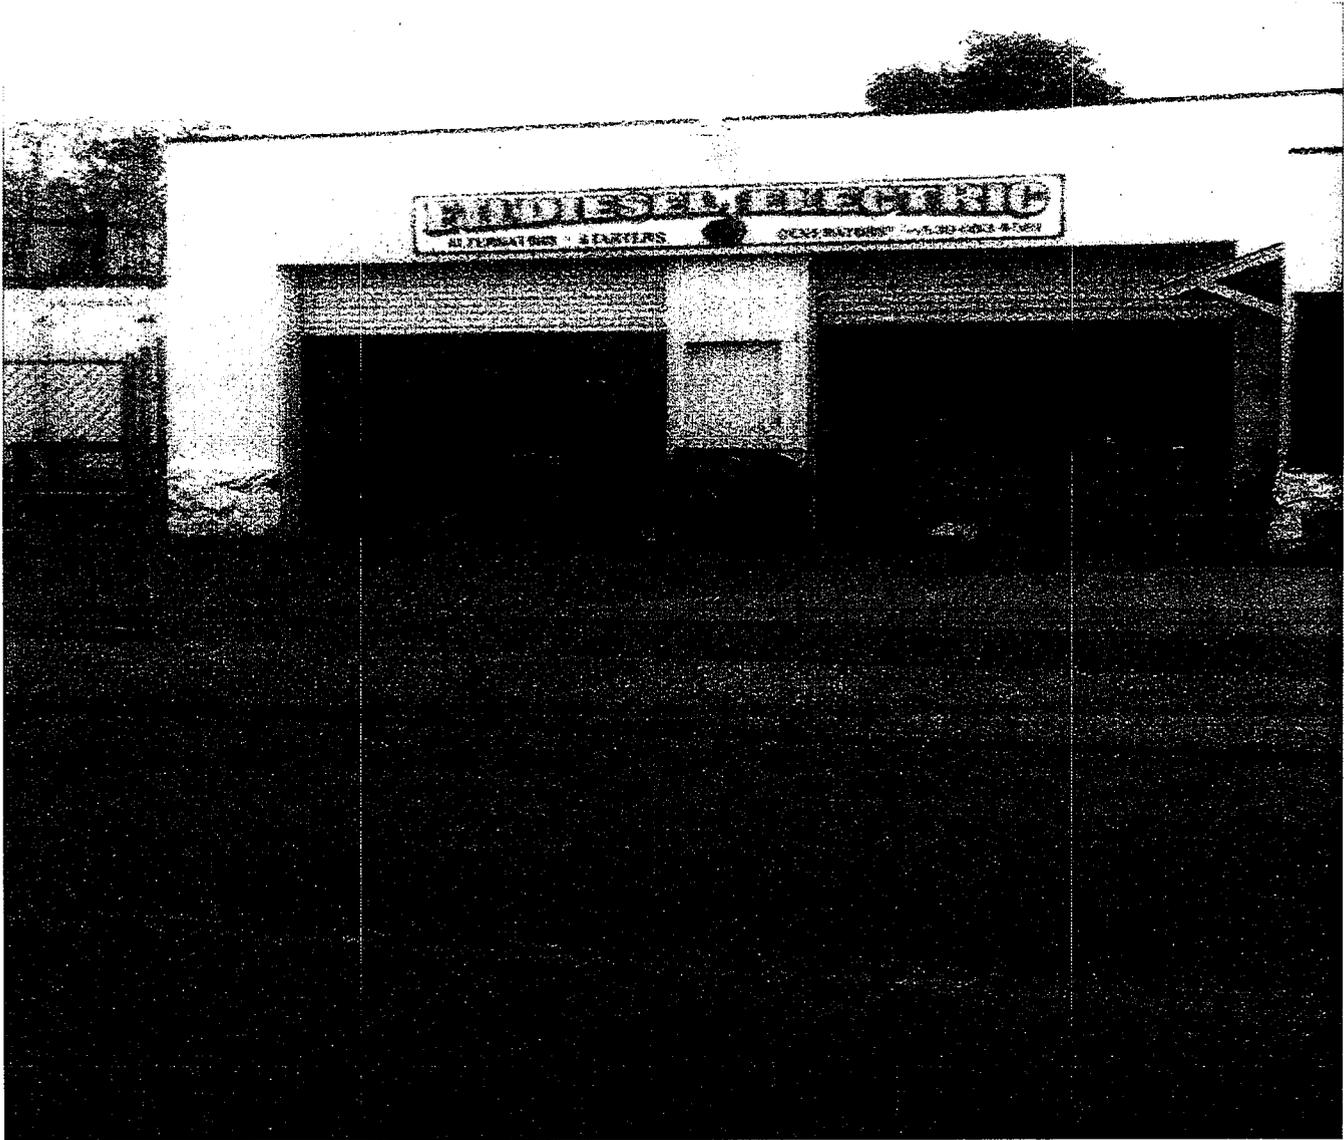
DTSC visited the site on March 28, 2013. The business consists of one small building, a partially unpaved parking area and an undeveloped grassy area on the site to the north of the building. The site is flat with good visibility around the entire site. No evidence of any drums, tanks, or of any releases to the ground was noted.

View of the site from across Myers Street looking to the east.

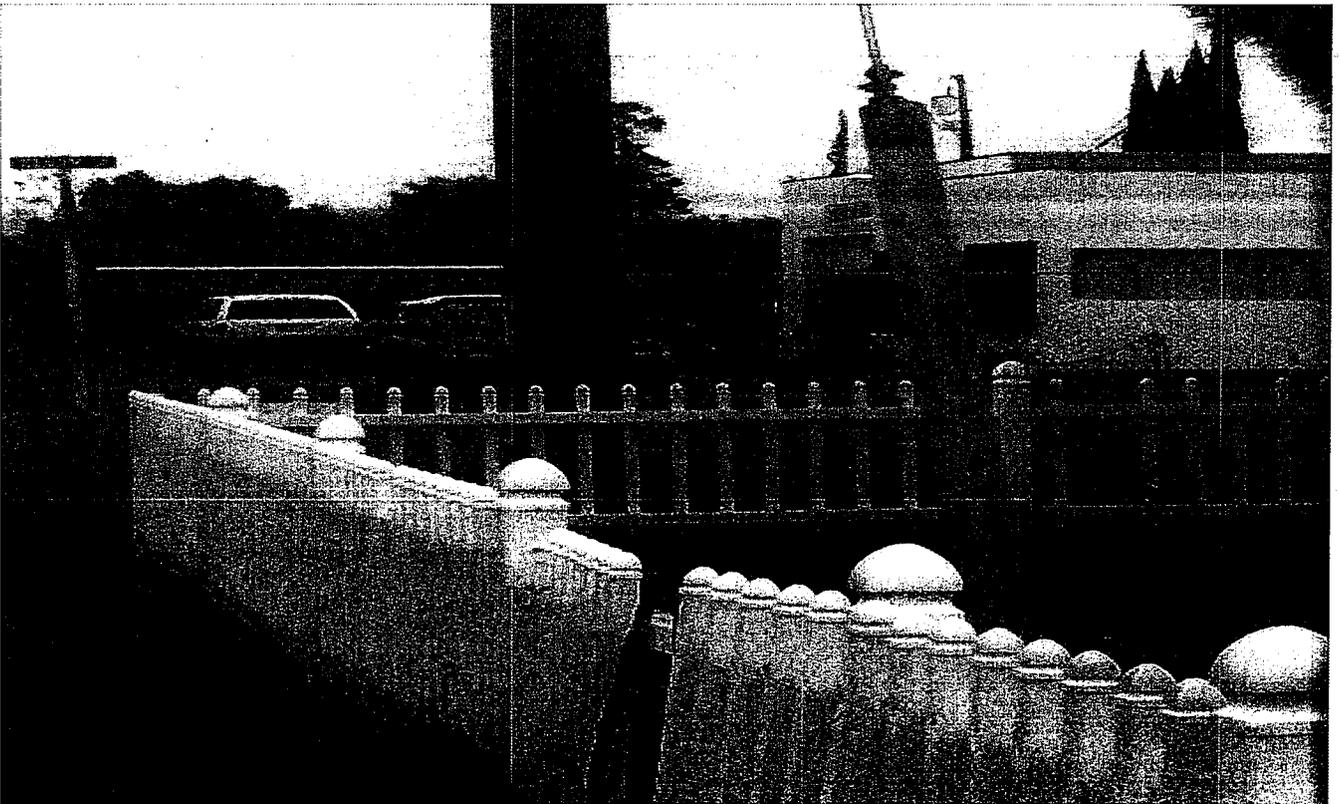
View of the site from the residence immediately behind and next to the site looking to the northwest.
